STATE OF VERMONT	SURVEY NUMBER: 110
Division for Historic Preservation Montpelier, VT 05602	Part of: District
HISTORIC SITES & STRUCTURES SURVEY	Complex
Individual Structure Survey Form	Contributing Non-Contributing Listed on: State Register of Historic Places
COUNTY: Chittenden	National Register of Historic Places
TOWN: Burlington VILLAGE:	CRITERIA: A B C D
LOCATION: 14 Strong Street	NEGATIVE FILE NUMBER:
	COORDINATES:
PROPERTY TYPE: House	UTM (ZONE 18) E 0 N 0 VSP (NAD 83) E 442502.55685 N 220889.7185
OWNER: Anya Schwartz	E911 E N
ADDRESS:	PRESENT FORMAL NAME:
	COMMON NAME: 14 Strong Street
ACCESSIBILITY TO PUBLIC:	ORIGINAL FORMAL NAME:
Yes No Restricted Restricted	
HISTORIC CONTEXT: Physical Patterns of Communities	PRESENT USE: House
,	ORIGINAL USE: House
SIGNIFICANCE:	ARCHITECT/ENGINEER:
Architectural 🗸 Historic 🗌 Archeological 📗 Engineering 🗌	BUILDER/CONTRACTOR:
LEVEL OF SIGNIFICANCE:	07/45
Local 🗸 State 🗌 National 🗌	STYLE: Colonial Revival; Queen Anne;

VERMONT DIV. FOR HISTORIC PRESERVATION
14 Strong Street; Three-Quarter View; 2005
Property Name: 14_Strong_Street_2 Survey #: 110 Direction of View: NW Filename: 14_Strong_Street_2.jpg Photographer: Elizabeth Andre

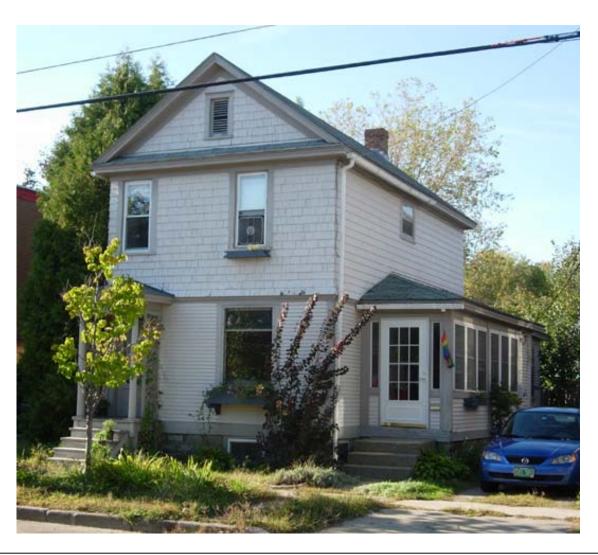
14 Strong Street is a two-story, gable-front, side-hall structure in the Queen Anne to Colonial Revival transitional style. A Colonial Revival entry porch shelters the left-bay entrance, and a large picture window topped with a stained glass transom opens into the right bay. A pediment roof tops the wood shingled second story, while wood clapboards sheath the first story. An enclosed porch shelters a side entrance on the easterly elevation.

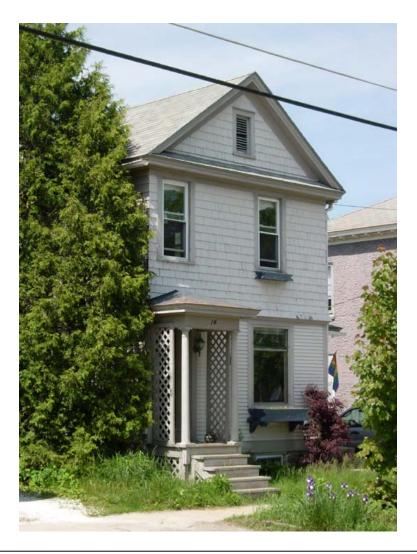
Property Name: 14_Strong_Street Survey #: 110 Direction of View: NE Filename: 14_Strong_Street.jpg Photographer: Elizabeth Andre

14 Strong Street; Main Facade; 2005

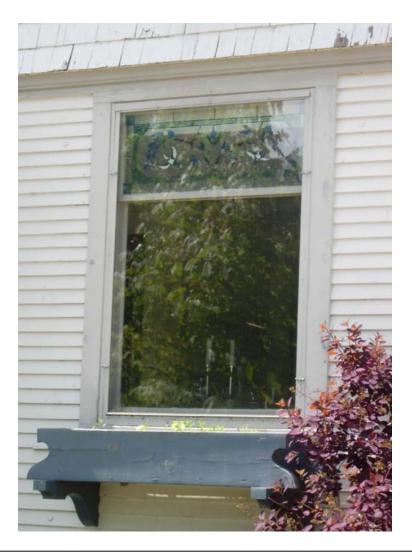
VERMONT DIV. FOR HISTORIC PRESERVATION
14 Strong Street; Window; 2005
Property Name: 14_Strong_Street_window Survey #: 110 Direction of View:
Filename: 14_Strong_Street_window.jpg Photographer: Elizabeth Andre

Queen Anne window; pedimented gable; door hood; entry columns; 1/1
